BAY MILLS INDIAN COMMUNITY

Green Community Assessment and Recommendations

2022

**Bay Mills Indian Community
The Big Green Up Report
2022**

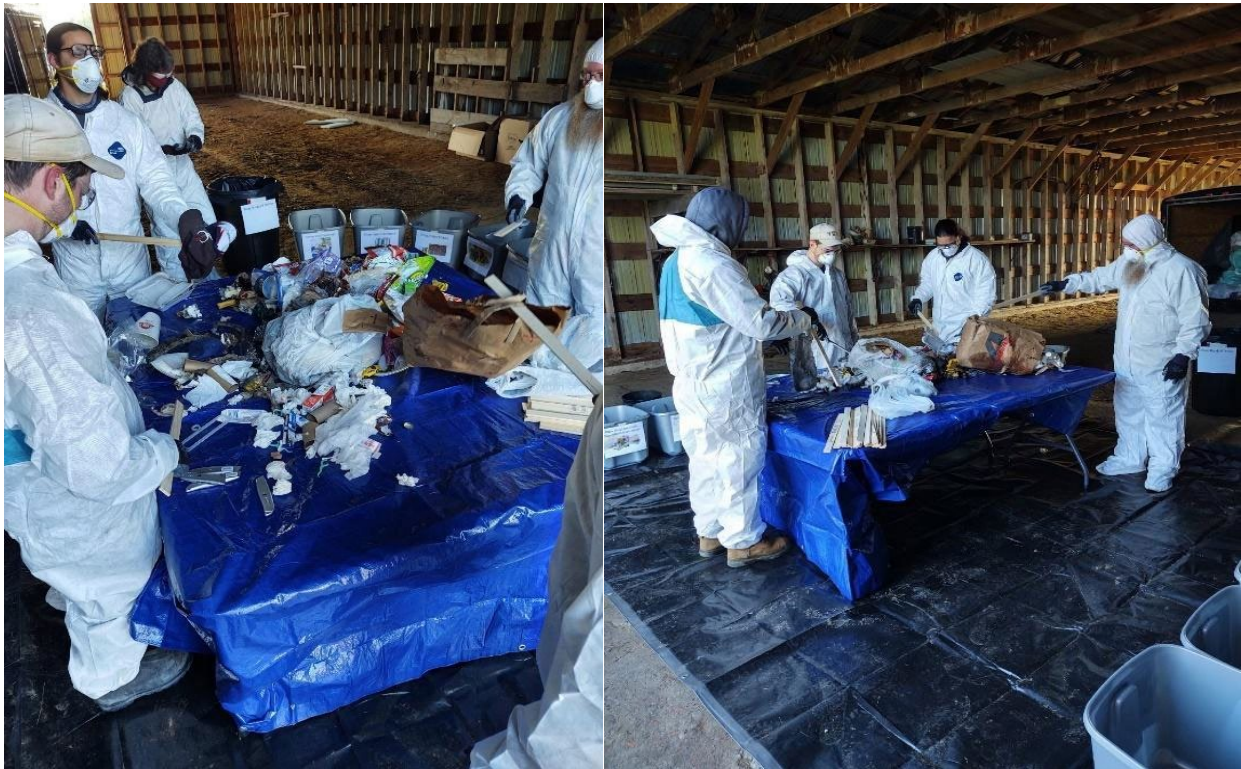
Figures 3.3.i and 3.3.ii Staff sorting waste at 2020 characterization survey.

Waste was collected in a 16ft enclosed trailer for the week leading up to the sort. In all a total of 9 volunteers composed of BMIC, ITCMI, and EPA staff were able to sort through a total of 677 lbs of waste over the course of an 8 hour day. The waste was sorted into 26 categories. These categories were chosen to determine what waste could potentially be removed from the waste stream and recycled with increased infrastructure, outreach, and/or education. The categories that were used as part of the study were chosen to identify recycling facilities that could be immediately available to the BMIC through outside contracts and to determine what types of alternative waste disposal could be feasible for the BMIC to implement directly.

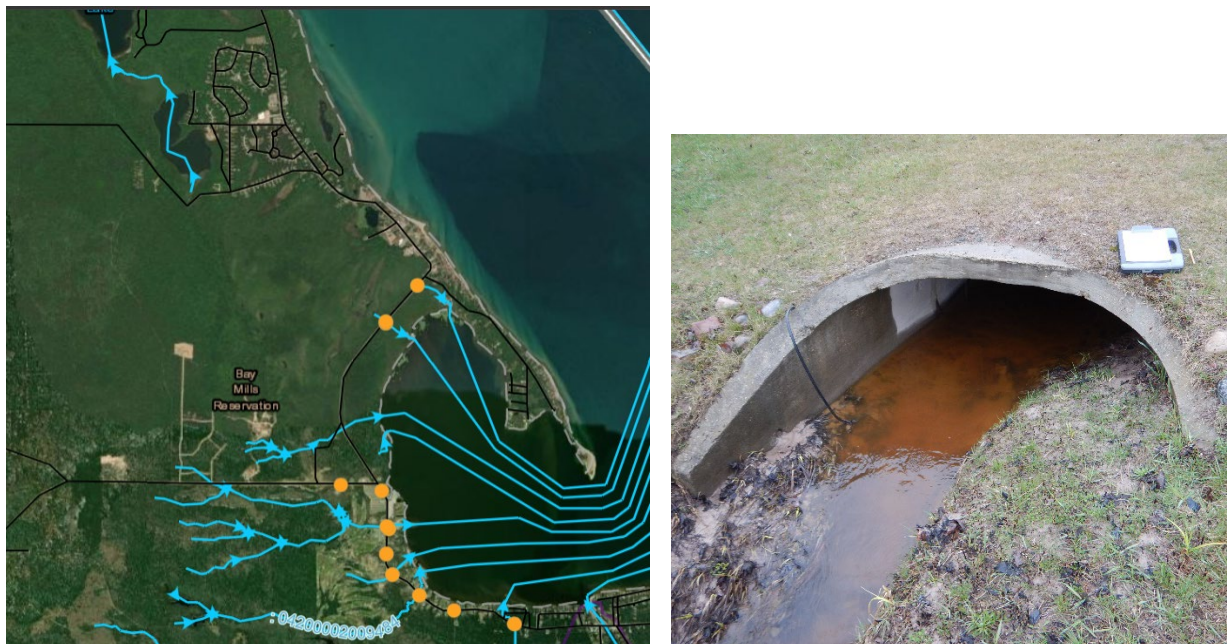
Figure 6a. Road-stream-crossing locations around Waishkey Bay. Many more driveway and ditch culverts exist, but were not assessed. Figure 6b. High priority crossing 281/282 at BMRC.

The Waishkey River Watershed Management Plan of 2020 included extensive surveys of area road stream crossings (whether they are culverts or bridges). Many, many more culverts exist in this area, allowing for ditch drainage, etc; in this survey, only crossings of permanent streams were surveyed. Information was collected at a dozen specific crossings on Bay Mills trust land within the Waishkey watershed (see Figure 6a). Data collected from the stream-crossings surveys revealed point- and nonpoint sources of contamination. Many of the culverts in the watershed and Bay Mills are undersized and should be considered for replacement. Additionally, their style may be ill-suited for the flashy, clay streams they are placed in. The metal or concrete of these structures may be in largely good condition, but due to alignment, sizing, embedded depth, etc, these structures are less than ideal for the environment and human infrastructure (see figures

and table below). Potential negative outcomes from improper RSC range from environmental degradation, to additional road maintenance, to catastrophic failure of the crossing. Of the RSC surveys completed at Bay Mills, most are undersized. Two RSCs (located at BMRC parking lot) are deemed high priority due to their alignment.
